# **DOCTORAL THESIS**

## **(SUMMARY)**

**INNOVATIVE ASPECTS REGARDING IMPLANTS USED IN  
ORTHOPEDIC CONDITIONS FROM THE PERSPECTIVE OF  
BIOMATERIALS**

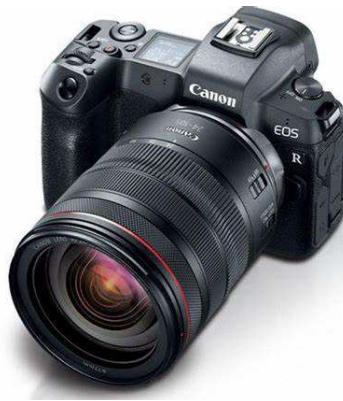
**Figure 5.1.** The DSLR camera used to obtain the macroscopical images

For the macroscopic evaluation of the explant, macrophotography techniques were initially employed. The images were captured using a Canon DSLR camera equipped with a 90 mm F/2.8 macro lens (Canon Inc., Tokyo, Japan), to obtain high-resolution details of the studied surfaces (Figure 5.1).

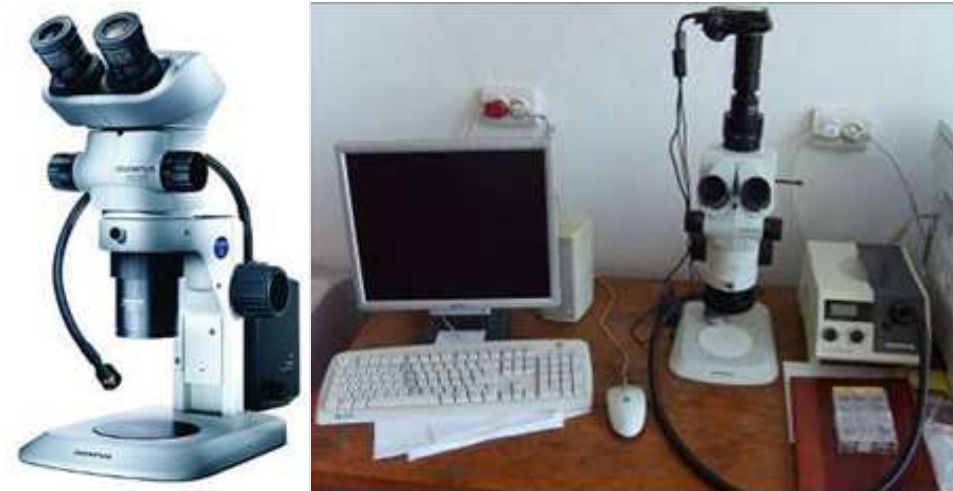
Stereomicroscopy was performed using a compact Olympus SZX7 stereomicroscope (Olympus Corporation, Tokyo, Japan), shown in Figure 5.2.

**Figure 5.2.** Olympus SZX7 Stereomicroscope

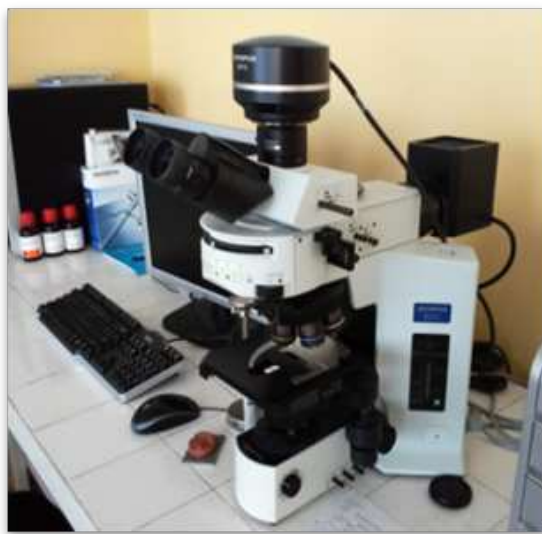
Finally, a metallographic etching is applied using chemical reagents, a process intended to highlight the structural constituents of the material, allowing a detailed evaluation under the microscope. Optical microscopy analysis was performed using an Olympus BX51 microscope (Figure 5.3).

**Figure 5.3.** Olympus BX51 Optical Microscope

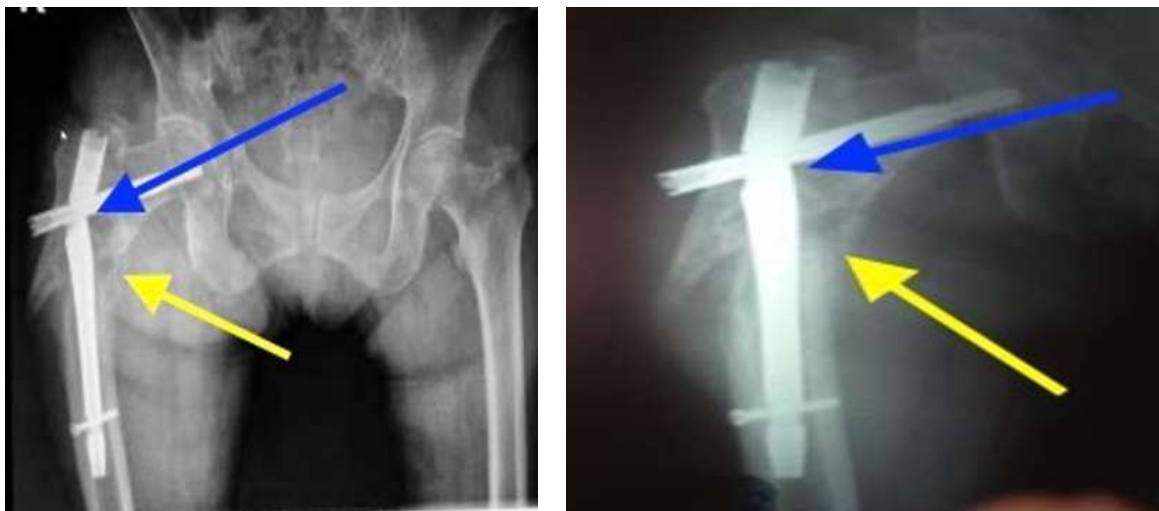
Six months after the intervention, the patient experienced pain and reduced mobility in the right hip. These symptoms are attributed to the lack of fracture consolidation, which may compromise the implant's integrity. These issues are illustrated in the presented X-ray (Figure 5.6).

**Figure 5.6** Radiographic images showing the implant deterioration (blue arrow) and the absence of bone healing (yellow arrow)

Following the radiographic evaluation, it was decided to remove the implant and replace it with a dynamic condylar screw (DCS) system. After the Gamma nail was removed, it underwent experimental analyses to determine the causes of its functional failure.

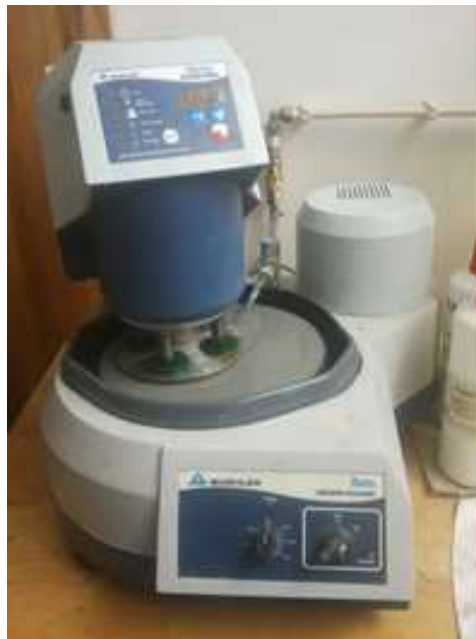
The grinding process aimed to achieve a perfectly flat surface, free of scratches. Grinding and polishing of the samples were performed using a Buehler Beta & Vector Grinder-Polisher device (Buehler, IL, USA), shown in Figure 5.11. The grinding process was carried out according to the parameters specified in Table 11, using CarbiMet2 hydrophilic metallographic paper under a continuous flow of water. At the end of the procedure, the sample was rinsed with clean water to remove any residual abrasive metallic dust and subsequently dried by wiping.

**Figure 5.11** Buehler Beta & Vector Grinder – Polisher

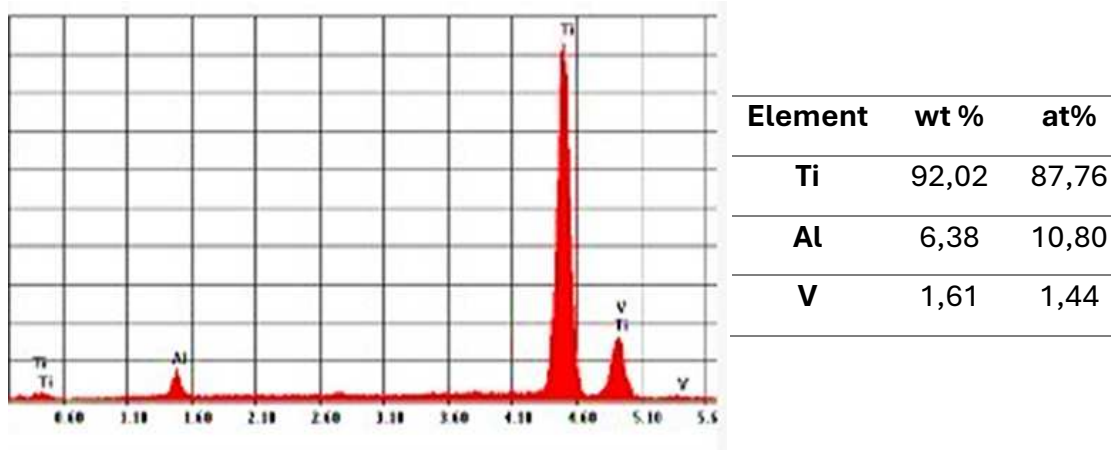
Following the quantitative and qualitative analysis performed on the failed material, along with the analysis of the X-ray emission spectrum, an evaluation of the Gamma rod's composition was conducted. It was found that the material primarily consists of titanium, aluminum, and vanadium, characteristic of Ti6Al4V titanium alloys, as shown in Figure 5.15.

**Figure 5.15.** EDS spectrum and compositional analysis results of the Gamma nail
